## **SERVICE BULLETIN**

RE: Ford 6.8L E-series cutaway bus chassis with PennTex charging systems.

Bulletin date: Sept. 3, 2010

### **OEM or Aftermarket Alternator Relocation (or Other High Current Line/Sources over 10 Amps) on 6.8L Gas Engine FEAD (Proximity to Throttle Body/ Throttle Position Sensor)**

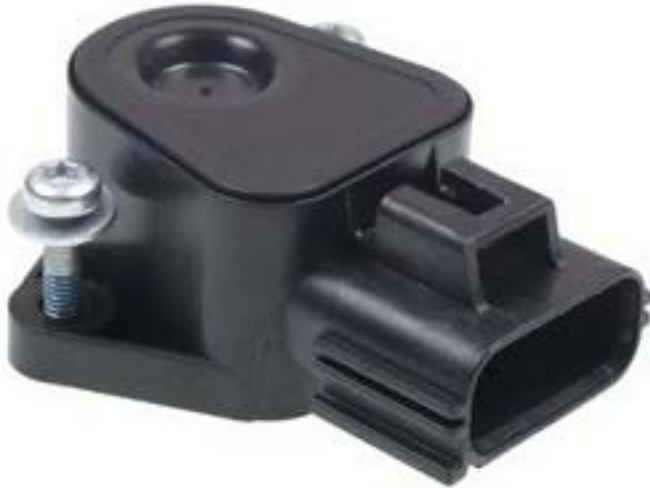
Earlier Potentiometer-style TPS

- \* Triangle Shaped
- \* Spring-loaded
- \* Not affected by magnetic interference

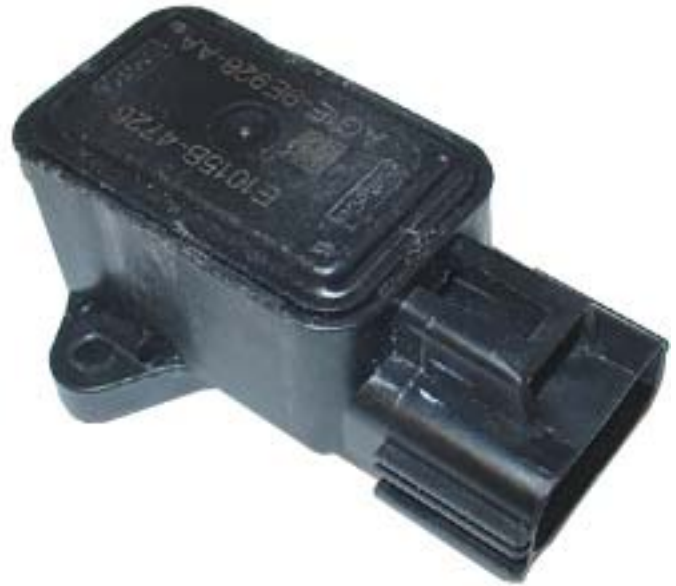
Later Magnetic-style TPS

- \* Rectangle Shaped
- \* Not Spring-loaded

The PennTex PX-7010 Shield is only designed to fit the later magnetic-style sensor

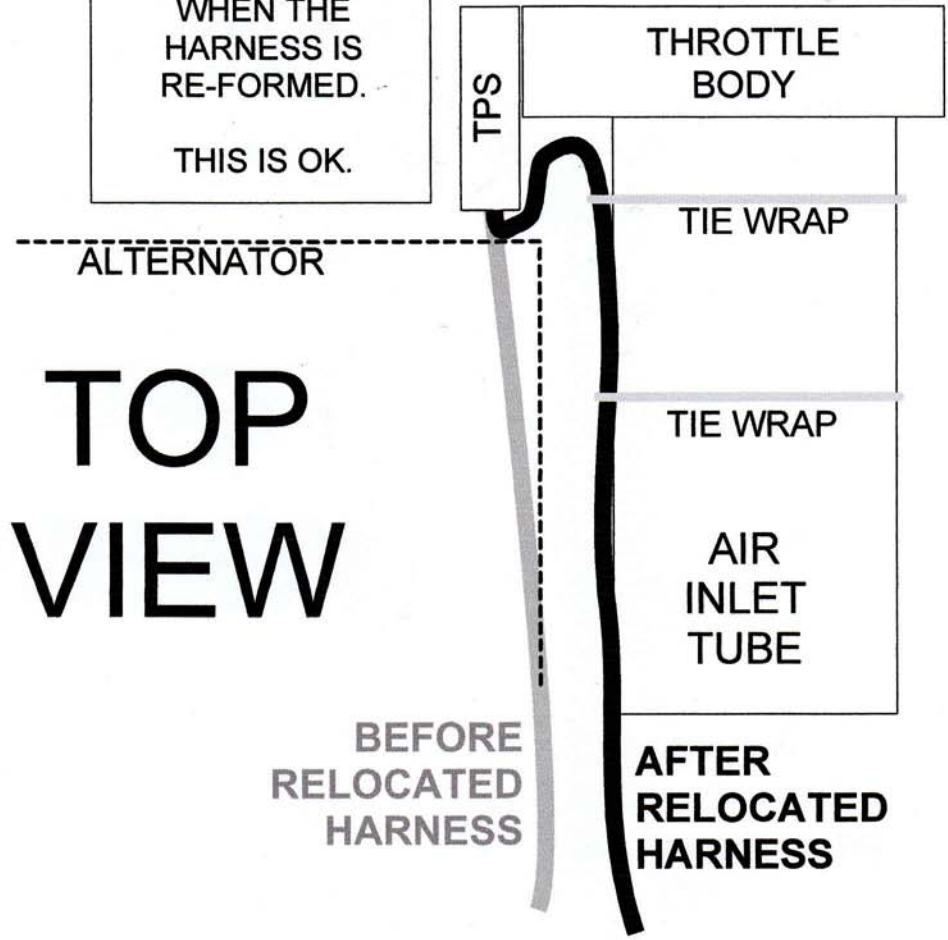
# ROUGH DRAWING OF TPS HARNESS ROUTING TO CLEAR PENNTEK ALTERNATOR

A WIRE SUPPORT  
FOR THE HARNESS  
AT THE TPS  
CONNECTION  
WILL BREAK OFF  
WHEN THE  
HARNESS IS  
RE-FORMED.

THIS IS OK.

7. Reinstall the components in reverse order. Note with some bracket kits it is advisable that the TPS Sensor's Harness should be secured away from the rear of the alternator in order to gain physical clearance. Some installers have successfully used cable ties to attach it to the air intake duct.
8. Allow time for the adhesive to cure. Reconnect battery grounds. Restart engine and verify drivability.
